Investigating Corrosion Protection of Offshore Wind Towers

Part 2: Results of the Site Tests

This article is the second part of a report on a nationally funded project on the performance testing of different corrosion protection methods for offshore wind towers under site and laboratory conditions. Part 1, published in the April 2008 *JPCL*, reported on the rationale behind, and setting up of, the test program. The present article discusses the test results.

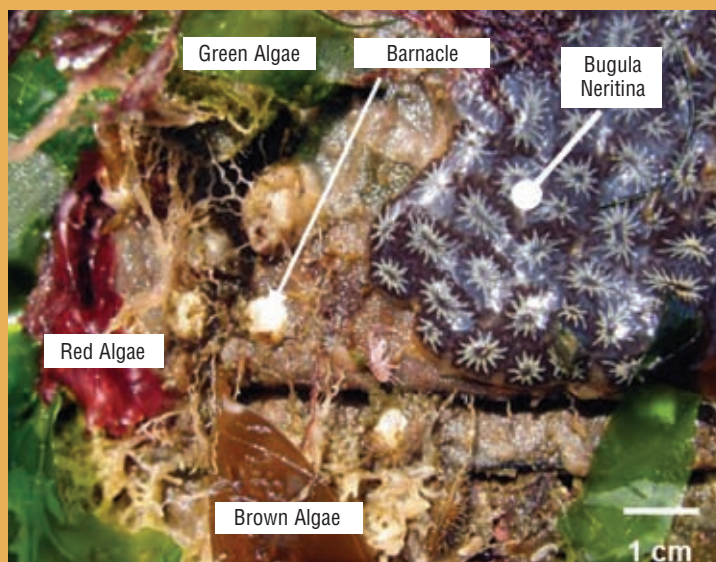
Fig. 1: Fouling at an underwater zone (UZ) specimen
 Photos and figures courtesy of the authors

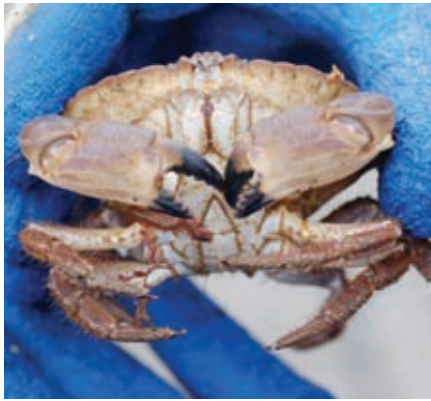
Fig. 2: Great crab, domiciliated in the underwater zone (UZ)

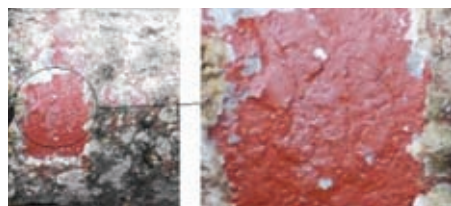
Fig. 3: Coating delamination at System 5 after 36 months of UZ exposure

System 6 exhibited large-scale blistering and severe coating delamination. This sample could not be cleaned properly because high-pressure washing would have removed the deteriorated coating. The sample showed white corrosion products, which were identified as the corrosion product of the metallization. The total system could be removed by scratching it slightly with a fingernail (Fig. 3). Because metallization with adequate sealers (at least Al/Zn metallization) is usually an effective and proven method for protecting offshore steel structures,^{10,11,12} the result was surprising. No conclusive explanation can be delivered at the moment, and

6	-	-	-	-	Not measured	Assessment was performed at fixing points only Large-scale blistering and coating delamination ³⁾

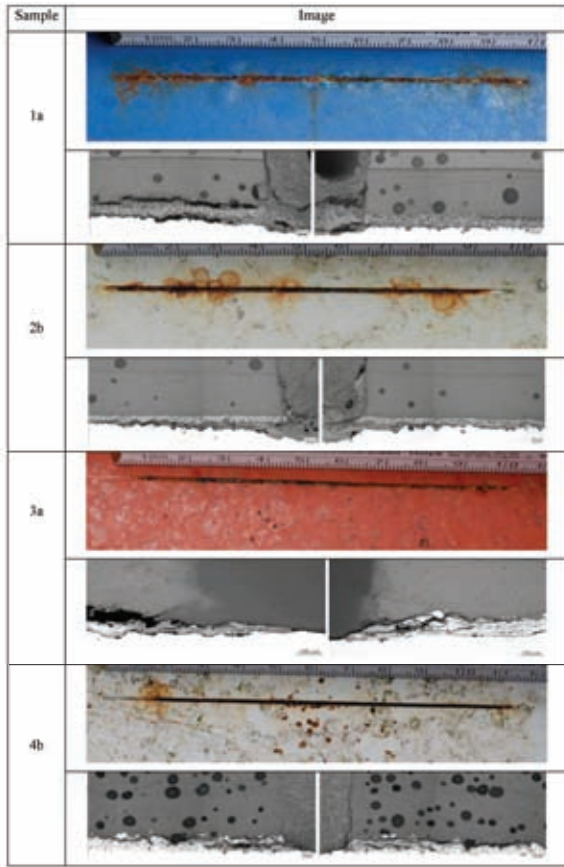
Table 7: Corrosion (upper image) in, and Paint Delamination (lower image; cross section view) at the Artificial Scribe at the IZ Specimens

Notable effects were found for Systems 1 and 2. The scribe delamination was about 2 mm for sample 1a and about 1 mm for sample 1b. The sample 1a exhibited severe corrosion at the scribe (Table 7). Scribe delamination was about 2 mm for sample 2a and about 3 mm for sample 2b. Both samples for System 2 showed limited corrosion at the artificial scribe. Sample 1a exhibited blistering up to a distance of 10 mm from the scribe.

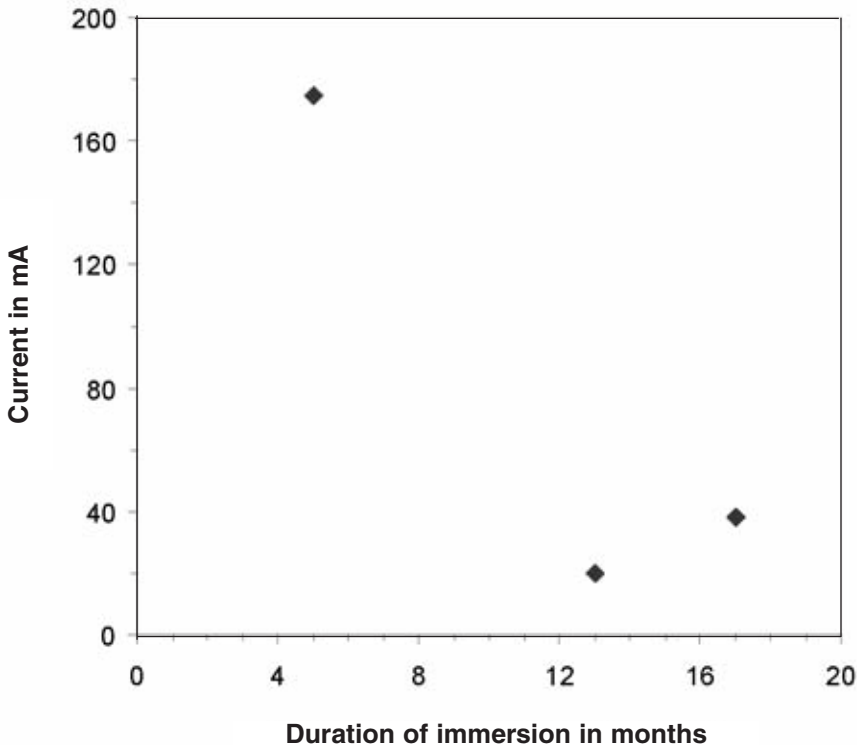
Fig. 4: Current consumption of cathodic protection of UZ samples

cathodic protection measurements. During the first months, the sample remained unprotected for technical reasons. The current had rather high values, which may have been caused by initial corrosion of the unprotected samples. After the cathodic protection was introduced, the value for the current dropped, and it seemed to be constant for the entire exposure phase. Coverage by fouling and the precipitate of alkaline earth salts are two probable reasons for the continuously low values for the protective current. Unfortunately,

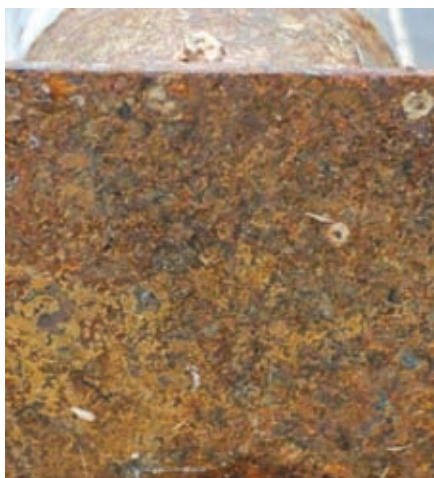
Fig. 5: Unprotected section of a UZ specimen after 36 months of exposure

part of the cathodic protection device was destroyed due to heavy wave load after 17 months, and it did not work properly. Therefore, the cathodic protection failed, and the uncoated sections of the specimens started to corrode.

The uncoated sections featured two layers of corrosion products (Fig. 5). The layer next to the steel was a black, loosely adherent layer, which was identified as Fe-oxide, more specifically, Fe-hydroxide with a low oxidation number. The top layer was the typical red rust, also loosely adherent. Figure 6 provides an SEM image and an EDX spectrum taken from the external corroded wall of the uncoated section of an UZ specimen. It can be seen that the rust was already cracked. Crack lengths ranged from 0.25 to 1.5 mm. Rust flakes were partly separated and only loosely adhering to the steel. The honeycomb structure in the far right region of the photograph is residue of fouling, and may be the origin of Si and partly of S and Na, occurring in the

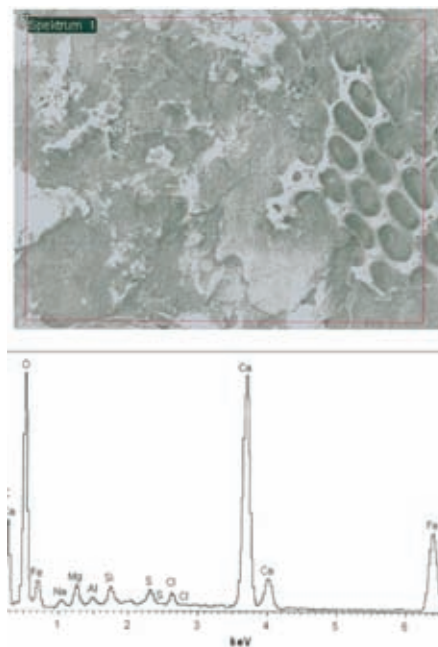
Fig. 6: SEM image (upper image; image width: 5 mm) and EDX plot (lower diagram) of the corroded external wall of UZ specimen 2 after 36 months exposure

EDX spectrum. The Fe-peaks in the spectrum originate from the corrosion products formed at the surface. The elements Al, Cl, Ca, Mg, S, and Na are constituents of the seawater.
