Who Reads Instructions Anyway?

The Case of the Failing Floor Coating

By Rick A. Huntley, Senior Coatings Consultant, KTA-Tator, Inc.

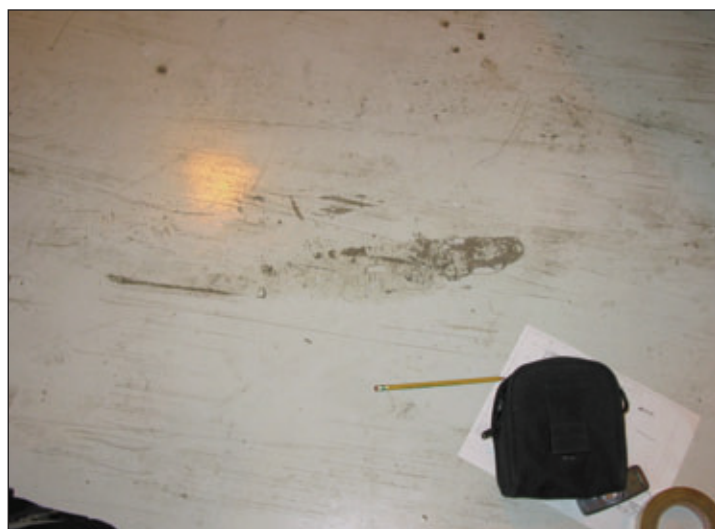
Fig 1: Most scratches on warehouse floor were parallel to length of aisle. Photos courtesy of the author

The floor had been coated with a gray-colored coating material. In various areas, there was also yellow striping on the gray floor. The floor was scratched and marred to various degrees throughout most of the facility. Most of the scratches were aligned in the direction of the forklift traffic flow (Fig. 1). For example, most of the scratches in any particular aisle were parallel to the length of the aisle. There

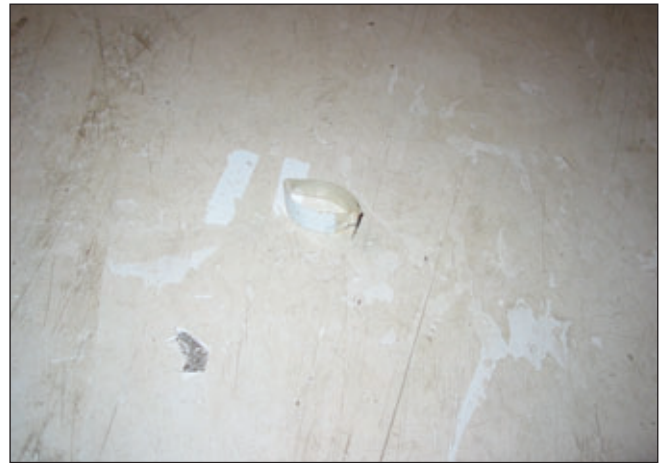
In many of the areas tested, the coating adhesion was extremely poor (Fig. 2). In some cases, the coating could be removed simply by applying the tape to the uncut topcoat and sharply pulling off the tape. In some other areas, the coating adhesion was rated good (4A), yet the topcoat could be removed by scratching at the surface with a finger-

Fig 2: ASTM Tape Test revealed poor coating adhesion

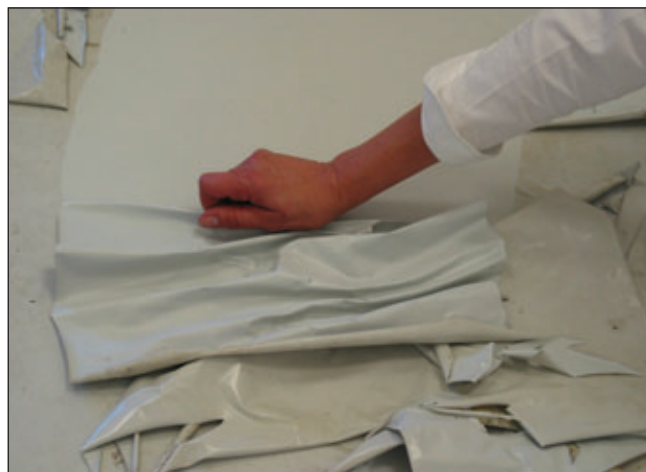
In areas where delamination was observed, the topcoat could be removed easily by cutting the surface with a utility knife and slipping the blade of the utility knife under the topcoat. In some cases, by continuing to tug at the coating, large sections could be removed in one piece (Fig. 3).

Fig 3: Large sections of coating delaminated with minimal manipulation.
