# Inspection and Evaluation of Lined Aboveground Storage Tank Bottoms in the Petroleum Industry

*Linings can complicate the inspection of tank bottoms. Here is an approach to surveying the complete surface of lined petroleum storage tank bottoms through the intact protective material.*

by Michael O'Connell,  
AEC Engineering

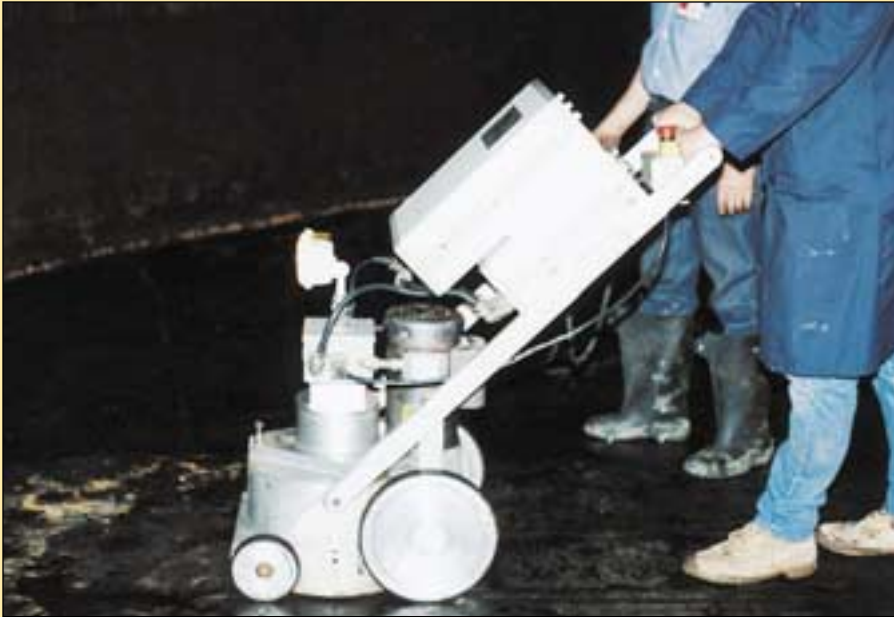
Fig. 1 - Currently available MFL/EC unit  
Figures 1 and 2 courtesy of Magnetic Analysis Corporation (Mt. Vernon, NY)

the size of a lawnmower) that are designed to detect product-side and soil-side corrosion in the steel bottom plates. Figures 1 and 2 show examples of currently available MFL units.

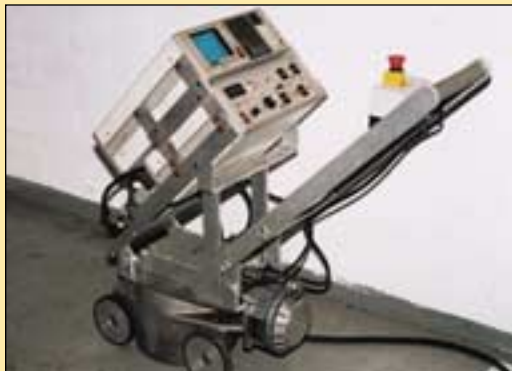
Fig. 2 - Currently available MFL/EC unit

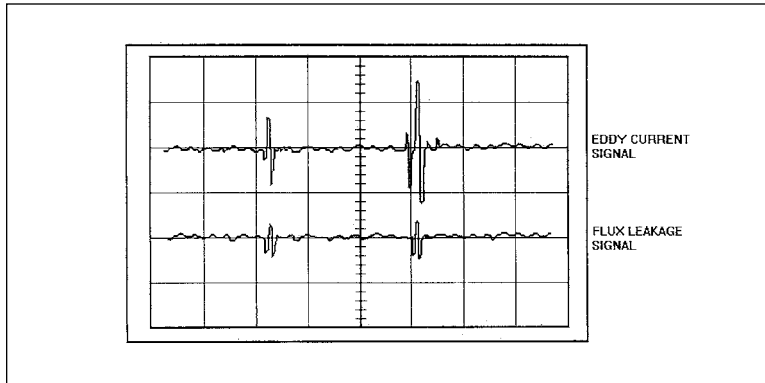
Fig. 3 - Schematic of signals caused by product-side (internal) corrosion pits  
*Figures 3-8 courtesy of the author*

Figure 3 shows the response from 2 product-side corrosion pits. Note the large

signals from the product-side eddy current trace and the smaller signals on the flux leakage trace. Figure 4 shows the response from 3 soil-side corrosion pits. The signals here are large responses on the flux leakage trace and a flat line signal on the top-side EC trace. The traces will both be flat if there is no corrosion.

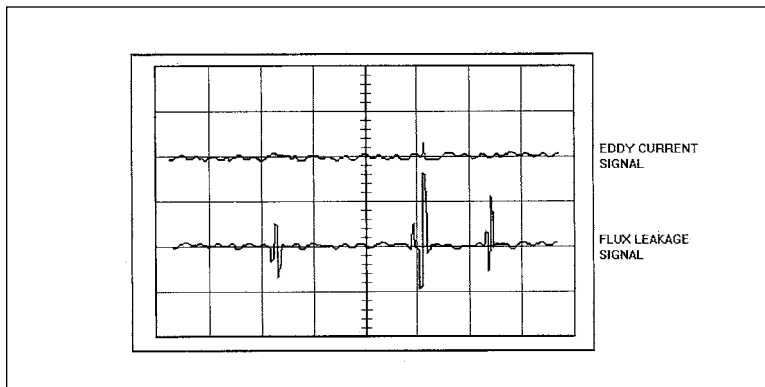
Fig. 4 - Schematic of signal caused by soil-side (external) corrosion pits

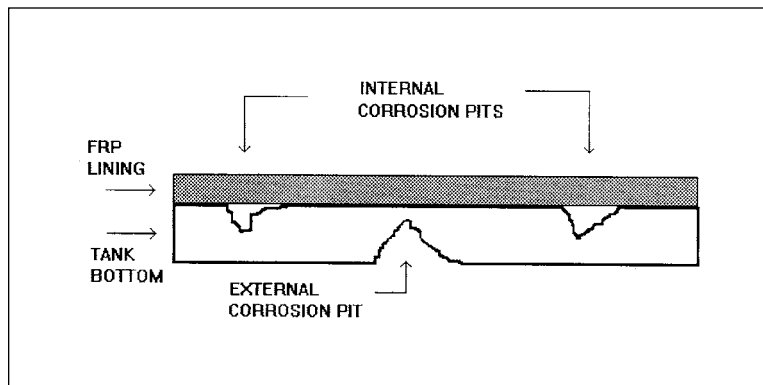
Fig. 5 - Illustration of tank floor having both internal and external corrosion lying under a fiberglass reinforced lining. Internal (product-side) corrosion pits correspond to fluctuations in eddy current signal in Fig. 6 below. External (soil-side) corrosion pit corresponds to middle fluctuation of flux leakage signal in Fig. 6 below.

Figures 5 and 6 illustrate how this combined technique can be used to detect and differentiate corrosion under a thick film lining system. During the inspection, the inspector looks for a signal typical of the one shown in Fig. 6.

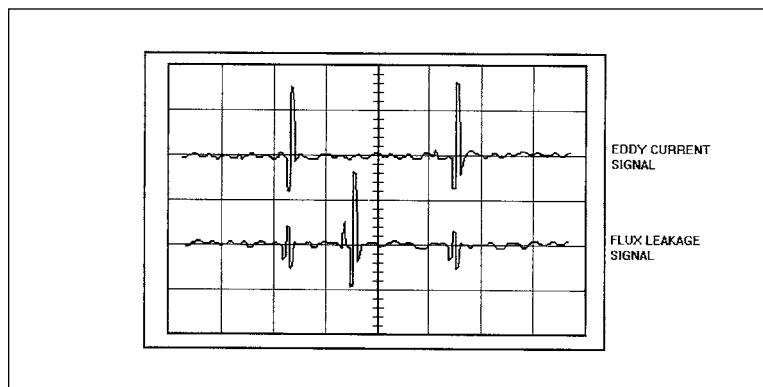
Fig. 6 - Schematic showing eddy current and flux leakage signals representing corrosion condition shown above

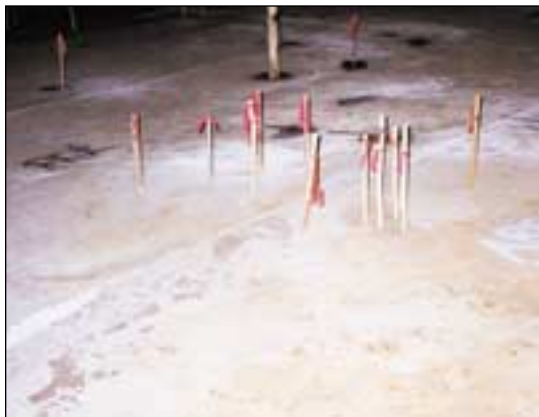
Fig. 7 - Numerous holes found by MFL/EC in lined tank bottom. (Note: Wooden stakes inserted into holes as location markers.)

This technique has been used successfully in inspections of lined AST bottoms in refineries, bulk storage terminals, and chemical plants over the past 3 years. Figures 7 and 8 show examples of corrosion identified through a protective lining by a MFL/EC unit.

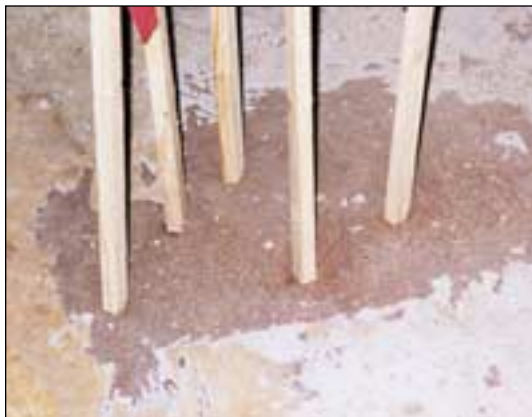
Fig. 8 - Detail showing holes verified by removal of the tank bottom lining
